**MIAMI DADE TRANST – OFFICE OF CIVIL RIGHTS AND LABOR RELATIONS
FTA KEY STATION 2003 ASSESSMENT FINDINGS FROM EXIT CONFERENCE
SUMMARY AS OF DECEMBER 2005**

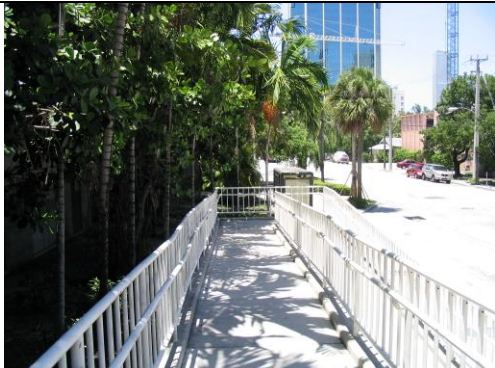
BRICKELL DECEMBER 2003 ASSESSMENT	FINDINGS	CORRECTIVE ACTION	EXHIBITS	DATE ITEM CURED
ACCESSIBLE ROUTE	<p>The tree limbs overhanging the station entrance ramp have grown so that they hang down into the accessible route and reduce the overhead clearance to 60 inches at the lowest points, as shown in Exhibit 3-36.</p> <p>Response: The tree limbs overhanging</p>	The tree limbs overhanging the station entrance ramp have been trimmed to provide the required 80" inches minimum clear headroom, as shown in Exhibit 3-36.	Exhibit 3-36 - Overhead Tree Limbs Obstruct Entrance Ramp	6/15/04

BRICKELL DECEMBER 2003 ASSESSMENT	FINDINGS	CORRECTIVE ACTION	EXHIBITS	DATE ITEM CURED
	the station entrance ramp will be trimmed.

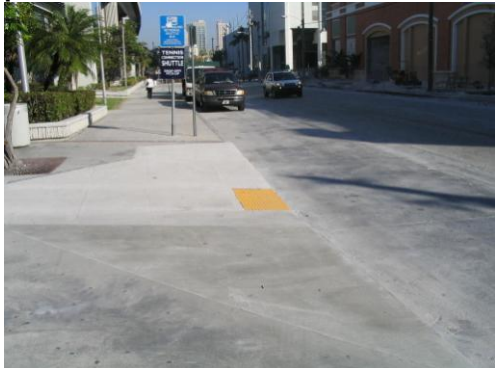
CURB RAMP	<p>The curb ramp at the Southbound Metrorail Shuttle bus stop pull-in lane, shown in Exhibit 3-37, has a slope of 14%.</p> <p>Response: A compliant ramp access will be constructed</p>	A compliant ramp access was constructed as shown in Exhibit 3-37.	<p>Exhibit 3-37 – Curb ramp at the Southbound Metrorail Shuttle Bus Stop pull-in lane.</p>

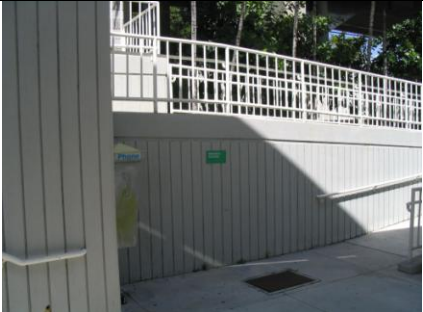
12/30/05
ENTRANCE	<p>Both entrances to the south end of the station are identified by visual signage, as shown in Exhibit 3-38</p> <p>Previous finding: Neither of the entrances</p>	The accessible entrance is the entrance to access the Metromover and Metrorail systems. An entrance sign with raised letter/Braille has been installed at	Exhibit 3-38(a)- South Entrance Braille/Raised Letter Station Entrance Sign	6/15/2004

BRICKELL DECEMBER 2003 ASSESSMENT	FINDINGS	CORRECTIVE ACTION	EXHIBITS	DATE ITEM CURED
	<p>to the station has a raised letter and Braille station entrance signs provided.</p> <p>These deficiencies remain.</p> <p>Response: Only one of two entrances to the south end of the station is accessible. An accessible signage will has been installed at the accessible entrance/ramp,</p>	<p>the accessible entrance/ramp, as shown in Exhibits 3-38(a) and 3-38(b).</p>

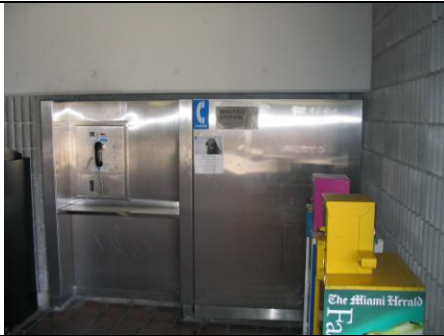
<p>The raised letter/Braille entrance sign at the north station entrance is blocked by a newspaper vending box, as shown in Exhibit 3-24.</p>	<p>The newspaper vending box was relocated, as shown in Exhibit 3-24.</p>	<p>Exhibit 3-24 – North Station Entrance - Raised Letter/Braille Entrance Sign</p>	<p>6/15/04</p>

BRICKELL DECEMBER 2003 ASSESSMENT	FINDINGS	CORRECTIVE ACTION	EXHIBITS	DATE ITEM CURED
	Response: The newspaper vending box will be relocated.

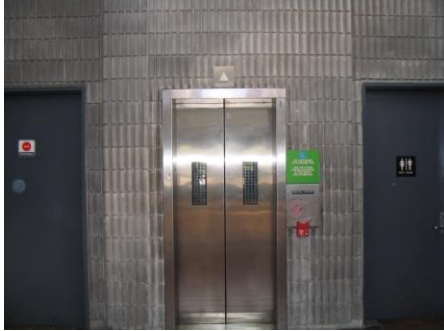
ELEVATORS	<p>Elevator (1) – North End Previous Finding: There are no vision panels at the street level of the north elevator. The deficiency remains, as shown in Exhibit 3-40.</p> <p>Response: Vision panels will be provided at the street level of the north elevator.</p>	Vision panels were installed at the street level of the north elevator as shown in Exhibit 3-40.	<p>Exhibit 3-40 – North Elevator – Street Level – Vision Panels</p>

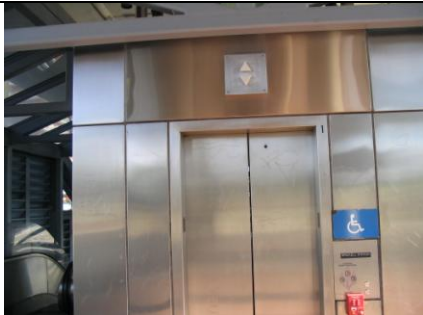
3/31/05
	Previous findings: The hall call buttons do not light and the hall lantern does not light on the north elevator.	The hall call buttons lights and the hall lanterns have been replaced, as shown in Exhibit 3-40(a)	Exhibit 3-40(a) – North Elevator – Hall Lanterns	11/4/04

BRICKELL DECEMBER 2003 ASSESSMENT	FINDINGS	CORRECTIVE ACTION	EXHIBITS	DATE ITEM CURED
	Response: The hall call buttons and the hall lanterns will be replaced.

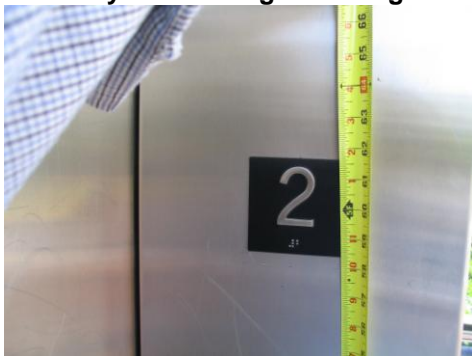
BRICKELL DECEMBER 2003 ASSESSMENT	FINDINGS	CORRECTIVE ACTION	EXHIBITS	DATE ITEM CURED
	<p>The hoistway floor designation signs on the elevator at the south end of the station (#2), shown in Exhibit 25, are mounted at 56 inches above the platform surface.</p> <p>Response: The hoistway floor designation signs will be mounted at 60" inches.</p>	<p>The hoistway floor designation signs on the elevator at the south end of the station (#2) were mounted at 60 inches from the platform surface to the centerline of the characters, as shown in Exhibit 3-25.</p>	<p>Exhibit 3-25 – Elevator South End of Station – Hoistway Floor Designation Sign</p>

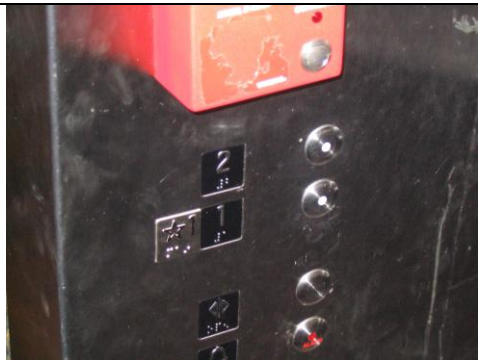
GOVERNMENT CENTER DECEMBER 2003 ASSESSMENT	FINDINGS	CORRECTIVE ACTION	EXHIBITS	DATE ITEM CURED
	upper/lower case (all elevators). The deficiency has been corrected, as shown in Exhibit 3-31			
	Previous finding: The car position indicators are ¼ inch high and have no audible signal (all elevators). These deficiencies have been corrected, as shown in Exhibit 3-32.			
	Previous findings: Hall call buttons do not light on elevators 3, 5 and 6, the hall lanterns do not light on Elevators 5 and 6, and the floor buttons on elevator 5 do not light. All these deficiencies have been corrected.			
	The main entry floor control button on the street access elevator control panel (Car # 2) is not designated with a raised star, as shown in Exhibit 3-23. Response; The raised start will be installed adjacent to the main entry floor control button.	The raised star was installed adjacent to the main entry floor control button, as shown in Exhibit 3-23.	Exhibit 3-23 – Street Access Elevator Control Panel (Car # 2)	6/15/04

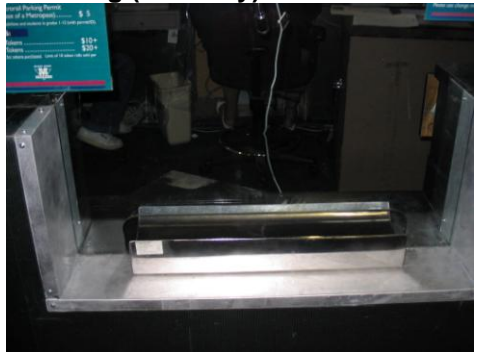
TICKETING	<p>Previous finding: The ticketing counter, shown in Exhibit 3-34, is 42 inches high. An auxiliary counter is not provided.</p> <p>Response: An auxiliary counter will be provided at the Ticketing counter (Transit Service Center).</p>	An auxiliary counter with a maximum height of 36 inches in close proximity to the main counter was provided, as shown in Exhibits 3-34(a) and 3-34(b).	<p>Exhibit 3-34(a) Ticketing (Auxiliary) Counter</p>

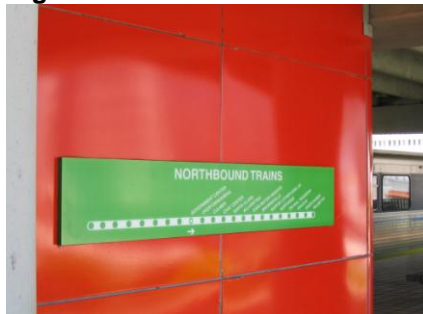
<p>Previous finding: There are no tactile or audio instructions for the vision impaired on the token/change vendors.</p> <p>The deficiency has been corrected.</p>			
PLATFORMS	<p>Previous finding: Some detectable edge tiles are missing along the platform.</p> <p>The deficiency has been corrected.</p>			
	<p>Previous finding: Overhead signs [mounted higher than 80 inches] have a character height of less than one inch.</p> <p>Although, the same information is provided in various areas of the station, including the platform, this condition remains.</p>	<p>Line Map (Destination) signs were installed at the eye level, as shown in Exhibits 3-35(a) and (b).</p>	<p>Exhibit 3-35(a) - Eye Level Destination Signs</p>

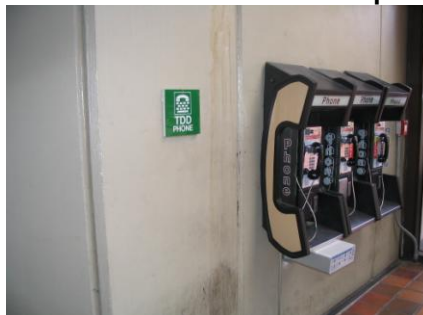
TELEPHONES	<p>Previous finding: There are no public text telephones on the mezzanine level where there are three public pay telephones. A text telephone has been installed at the fare mezzanine/food court level.</p> <p>The deficiency has been corrected.</p>		<p>Exhibit 3-36 – Public text telephone</p>

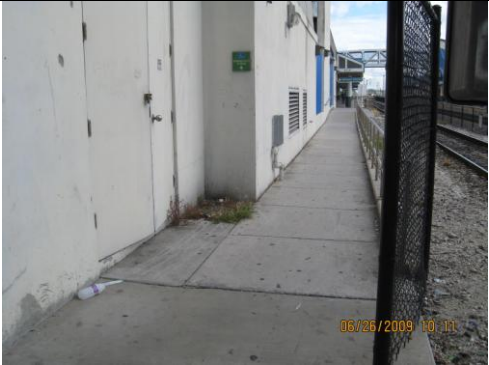
TRI-RAIL DECEMBER 2003 ASSESSMENT	FINDINGS	CORRECTIVE ACTION	EXHIBITS	DATE ITEM CURED
ACCESSIBLE ROUTE	<p>Previous finding: the most direct route from the bus stop at 79th Street and 11th Avenue is along 11th Avenue which is not accessible (no sidewalk). The</p>	<p>An accessible route has been constructed to connect the station accessible entrance to the streets and bus stops located across the</p>	Exhibit 3-23(a) Accessible walkway	6/15/05

TRI-RAIL DECEMBER 2003 ASSESSMENT	FINDINGS	CORRECTIVE ACTION	EXHIBITS	DATE ITEM CURED
	<p>International Symbol of Accessibility trailblazer sign is needed to show the way to the accessible walkway adjacent to the Tri-Rail tracks.</p> <p>The deficiency has been corrected, as shown in Exhibits 3-23 (a) and (b).</p>	<p>station, as shown in Exhibits 3-23(a), (b), (c), and (d).</p>

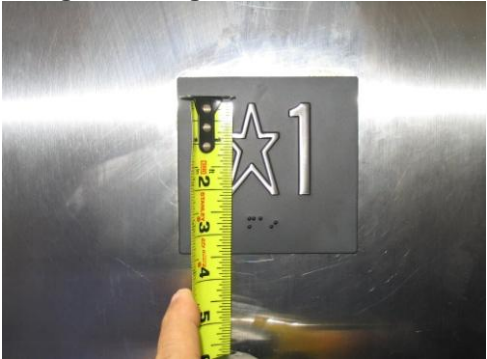
ELEVATORS	Previous finding: • The hall call buttons are not 42 inches from the floor.

TRI-RAIL DECEMBER 2003 ASSESSMENT	FINDINGS	CORRECTIVE ACTION	EXHIBITS	DATE ITEM CURED
	<ul style="list-style-type: none"> • Hall call buttons do not light when a call is register on Elevator 1 at street level and on Elevator 2 at bridge level. • There is no audible signal on the hall lanterns on Elevator 1 at the bridge level. • Three of the six ceiling light are out on Elevator 2. <p>The deficiency has been corrected.</p>			
	<p>Previous finding: There is no hoistway signage on Elevator 2 at the bridge and platform levels.</p> <p>Hoistway floor designation signs have been installed. However, the characters of the hoistway floor designation signs at all landing or both elevators at this station are 2 ½ inches high, as typified in Exhibit 3-24.</p>	<p>The 2 ½ inches high characters of the hoistway floor designation signs at all landing of both elevators at the station were replaced with 2-inch high characters, as shown in Exhibit 3-24..</p>	<p>Exhibit 3-24 Elevator Hoistway Floor Designation Sign</p>

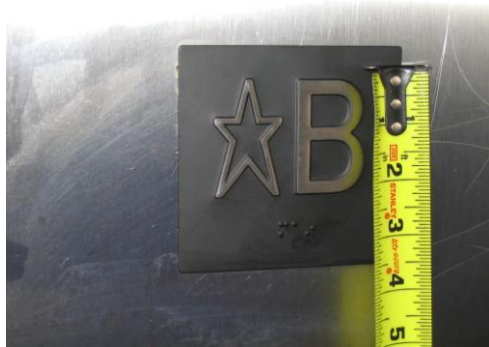
<p>Previous finding: The main entry floor control button on each elevator control panel is not designated with a raised star.</p> <p>These deficiencies remain, as shown</p>	<p>The raised star was installed adjacent to the main entry floor control button, as shown in Exhibit 3-25(a).</p>	<p>Exhibit 3-25(a) Elevator Entry Floor Raised Star Sign</p>	<p>6/15/04</p>

TRI-RAIL DECEMBER 2003 ASSESSMENT	FINDINGS	CORRECTIVE ACTION	EXHIBITS	DATE ITEM CURED
	in Exhibit 3-25.

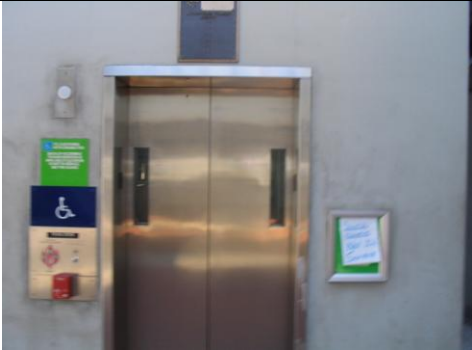
<p>Previous finding: The car position indicators in Elevator 2 do not light.</p> <p>The deficiency has been corrected.</p>			6/15/04
AUTOMATIC FARE VENDING AND COLLECTION	<p>Previous finding: There are no tactile instructions or audio on token vendors/change machines.</p> <p>The deficiency has been corrected.</p>			6/15/04
	Vision panels are not provided at the bridge and platform levels of the street access elevator and at both landing of the southbound platform access elevator.	Vision panels were installed at the bridge level and platform levels of the street access elevator, as shown in Exhibits 3-25(b) and 3-25(c). Vision panels were also	Exhibit 3-25(b) – Elevator Street Level Vision Panels	11/8/04

TRI-RAIL DECEMBER 2003 ASSESSMENT	FINDINGS	CORRECTIVE ACTION	EXHIBITS	DATE ITEM CURED
		added to both of the landings at the Southbridge platform access elevator.

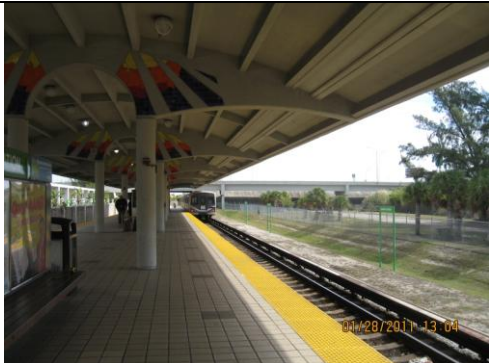
PLATFORMS	Previous finding: Approximately 100 feet of detectable edging is missing on both platforms in addition to other miscellaneous tiles missing.	New detectable warning surfaces (DWS) were installed throughout the system, as shown in Exhibit 3-25(1).	Exhibit 3-25(1)– New detectable warning surfaces	6/15/04

TRI-RAIL DECEMBER 2003 ASSESSMENT	FINDINGS	CORRECTIVE ACTION	EXHIBITS	DATE ITEM CURED
	The deficiency has been corrected.

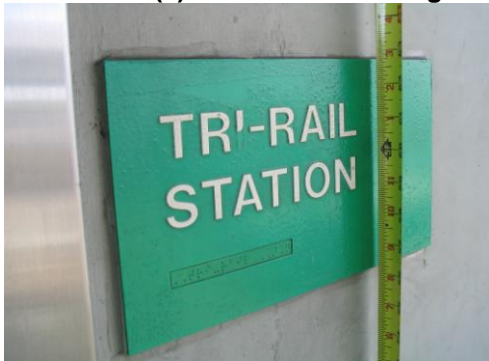
<p>Previous finding: The tactile station name signs on the platforms are mounted 42 inches above the floor instead of the required 60 inches.</p> <p>There are three raised letters and Braille station name signs provided on each platform, as typified in Exhibit 3-26. All six tactile signs are mounted at 40 to 42 inches to the center of the sign above the platform surfaces.</p>	<p>Two raised letters and Braille station name signs have been relocated to a height of 60" from the floor to center of sign on each platform, as shown in Exhibit 3-26(a).</p> <p>The signs were installed adjacent to the elevator banks, as shown in Exhibit 3-26(b).</p>	<p>Exhibit 3-26(a) Platform Tactile Sign</p>

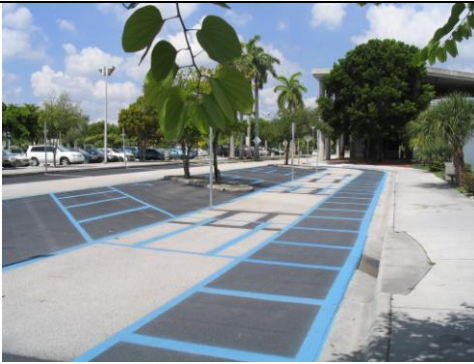
2. The seven newly painted accessible parking spaces provided in the surface parking lot, shown in Exhibit 3-5, are 8.5 feet to 9 feet in width and six of the adjacent access aisles are 72 inches	The seven (7) newly "van accessible" spaces provided at the surface parking facility have been reduced to four (4) spaces. Each of them was restriped exceeding	Exhibit 3-5(a) - Surface Parking Facility Van Accessible Spaces	6/15/04

OKEECHOBEE DECEMBER 2003 ASSESSMENT	FINDINGS	CORRECTIVE ACTION	EXHIBITS	DATE ITEM CURED
	wide. The remaining access aisle is 42 inches wide.	Florida Accessibility and Dade County Codes, as shown in Exhibit 3-5 (a). Each accessible space is 17 feet 8 inches in width with an access aisle of 12 feet.

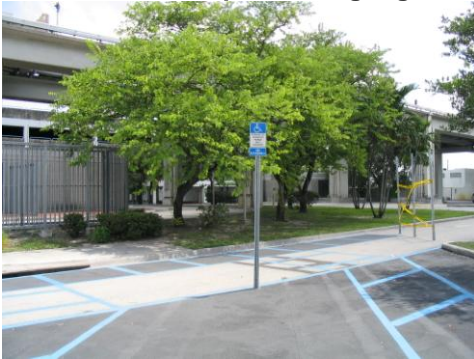
3. Signs are not provided that reserve the accessible parking spaces in the surface parking lot.	The four "van accessible" parking spaces provided at the surface parking lot area are reserved with signage in accordance with Florida Accessibility and Dade County Codes, as shown in Exhibit 3-5(b): "(The International Symbol of Accessible) Parking by Disabled Permit Only - Fine Up To \$250.00 - Van Accessible".	Exhibit 3-5(b) - Surface Parking Facility Van Accessible Spaces - Signage

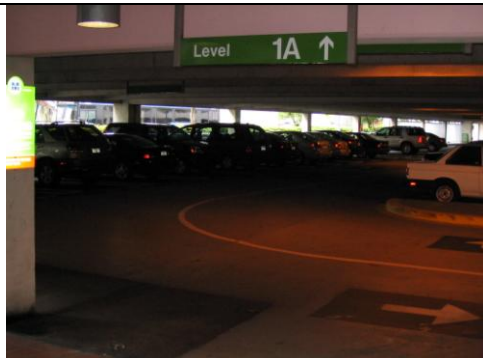
4. At the garage level 1A, there are eleven newly striped parallel parking spaces, shown in Exhibit 3-6. None of these spaces are reserved with signs	The eleven (11) newly striped parallel parking spaces provided at level 1A have been relocated to level 3A. No accessible parking	Exhibit 3-6 – Garage Level 1A Accessible parking spaces were removed	6/15/04

OKEECHOBEE DECEMBER 2003 ASSESSMENT	FINDINGS	CORRECTIVE ACTION	EXHIBITS	DATE ITEM CURED
	showing the accessibility symbol.	space is being provided at the garage level 1A.

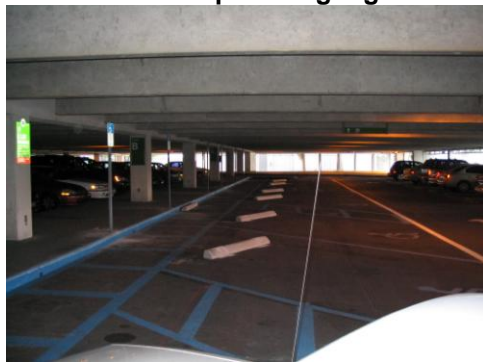
5. At the garage level 1B, there are 11 newly striped parking spaces that are not reserved with signage, as shown in Exhibit 3-7.	The eleven 11 newly striped accessible parking spaces at the garage level 1B have been and reduced to nine (9) spaces. Each accessible parking space is reserved with compliant signage, as shown in Exhibit 3-7: (The International Symbol of Accessible) Parking by Disabled Permit Only - Fine Up To \$250.00)	Exhibit 3-7 – Garage Level 1B Nine (9) accessible parking spaces reserved w/ compliant signage

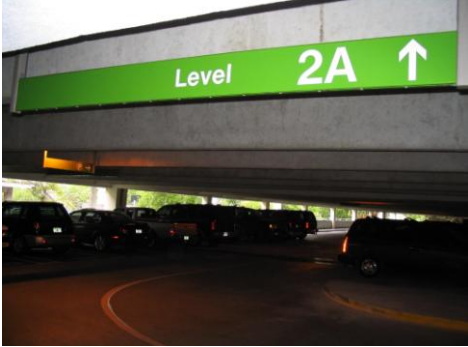
7. The 8 parking spaces provided on level 2 of the parking garage and the 8 spaces on level 3 of the parking garage are not yet striped, as typified in Exhibit 3-8.	The eight (8) accessible parking spaces on the garage level 2 areas (A and B) have been eliminated, as shown in Exhibits 3-8(a) and 3-8(b). .	<p>Exhibit 3-8(a) – Garage Level 2A</p>

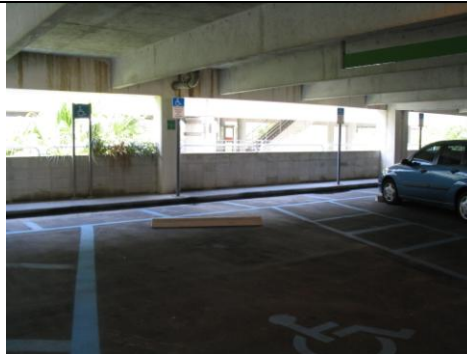
6/15/04
		The eighteen (18) accessible parking spaces provided on level 3A area were striped in compliance with Florida Accessibility Code with a width of 12 feet 10 inches, as shown in Exhibit 3-8(c). Every two spaces	Exhibit 3-8(c) Garage Level 3A Parking Area	6/15/04

OKEECHOBEE DECEMBER 2003 ASSESSMENT	FINDINGS	CORRECTIVE ACTION	EXHIBITS	DATE ITEM CURED
		are served by an access aisle of 5 feet wide. The accessible parking space provided on level 3B, one (1) space, was also restriped with a width of 12 feet wide and it is served by a 6 feet width access aisle.

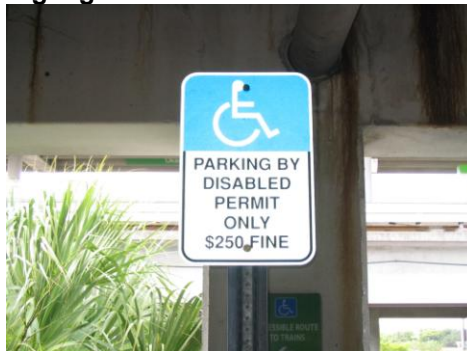
The accessible parking spaces at level 3 areas are reserved with compliant signage, as shown in Exhibit 3-8(d): "(The International Symbol of Accessible) Parking by Disabled Permit Only - Fine Up To \$250.00".	Exhibit 3-8(d) Garage Level 3 areas - Signage

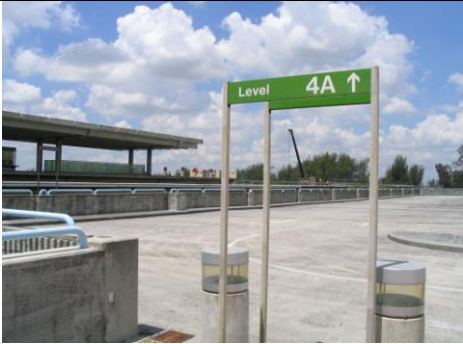
8. The 4 accessible parking spaces provided on level 4 areas of the parking garage do not have access aisles provided, as typically shown in Exhibit 3-9(a) and (b).	Level 4 of the garage is closed to the public. The four accessible parking spaces reserved at this level have been eliminated, as shown in Exhibit 3-9(a) and 3-9(b).	Exhibit 3-9(a) Garage Level 4A Area	6/15/04

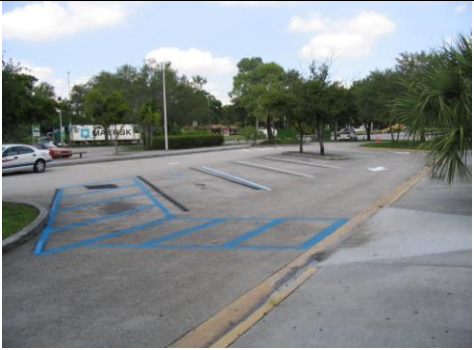
9. There are three designated passenger drop-off areas at this station: a kiss and ride/drop-off parking area at the north	One passenger loading zone complying with ADAAG 4.6.6 is provided at the north side of the	Exhibit 3-10(a) Passenger Loading Zone	6/15/04

OKEECHOBEE DECEMBER 2003 ASSESSMENT	FINDINGS	CORRECTIVE ACTION	EXHIBITS	DATE ITEM CURED
	side of the station entrance, shown in Exhibit 3-10; a designated drop-off lane adjacent to the accessible parking area; and another designated drop-off at the entrance roadway. ADAAG 4.1.5(c) states that if passenger-loading zones are provided, then at least one passenger-loading zone shall comply with ADAAG 4.6.6.	station (kiss and ride/drop-off area), as shown in Exhibit 3-10(a). The passenger-loading zone is 17 feet 4 inches in width and 21 feet in length.

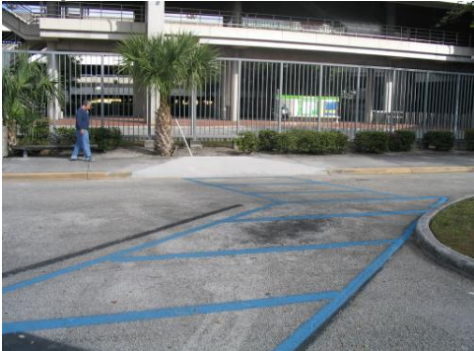
A photograph showing a designated passenger-loading zone at a station. The zone is marked with blue paint on the asphalt, forming a rectangular area. A yellow curb runs along the right side of the zone. In the background, there are trees and a clear sky.	
	Previous Finding: There is no curb ramp at the drop-off area. The condition remains at the kiss and ride/drop-off area, but curb ramps are provided at the other two drop-off areas.	As shown in Exhibit 3-10(b), a curb ramp is provided at the kiss and ride/drop-off area to access the elevator up to the fare mezzanine and up to the platform.	Exhibit 3-10(b) Passenger Loading zone Ramp

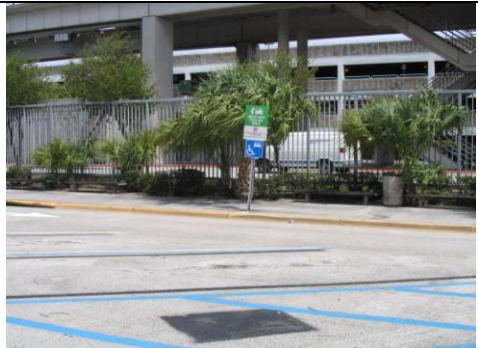
Previous Finding: There is not international symbol of accessibility at the drop-off area.	The passenger loading zone has been identified by the International Symbol of Accessibility, as shown	Exhibit 3-10(c) Passenger Loading zone - Signage

OKEECHOBEE DECEMBER 2003 ASSESSMENT	FINDINGS	CORRECTIVE ACTION	EXHIBITS	DATE ITEM CURED
	The deficiency remains.	in Exhibit 3-10(c).

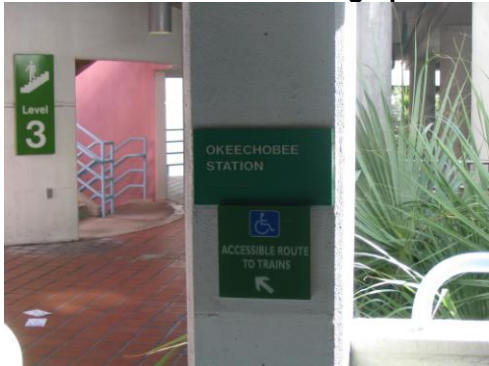
<p>On the accessible path from the garage level 1A accessible parking area is a 10.5 feet long walkway that is sloped an average of 7%. The area is shown in Exhibit 3-13.</p>	<p>The accessible parking spaces at level 1A have been relocated to level 3, as shown in Exhibits 3-13(a) and (b). The 10.5 feet walkway with a slope of 7% is no longer an element of an accessible path.</p>	<p>Exhibit 3-13(a) Level 3 – Accessible Route to Accessible Parking Spaces</p>

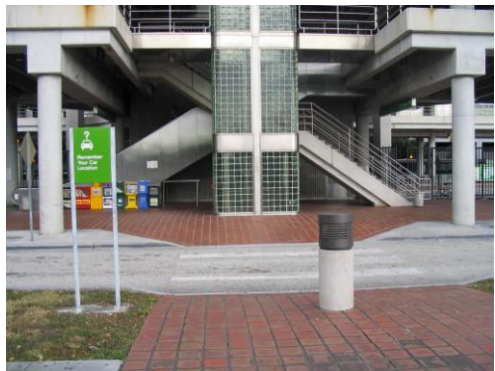
CURB RAMPS	12. Curb Ramp: The curb ramp at the entrance to the station, shown in Exhibit 3-14, has a slope of 18%.	The curb-ramp with a slope of 18%, shown in Exhibit 3-14, is an element of an inaccessible route. It connects the standard parking spaces provided at the surface parking lot (east of the station), the walk-on and the elevator # 2 to access the fare mezzanine and up to the platform.	Exhibit 3-14 Curb Ramp w/ slope of 18% It is not an element of the accessible route

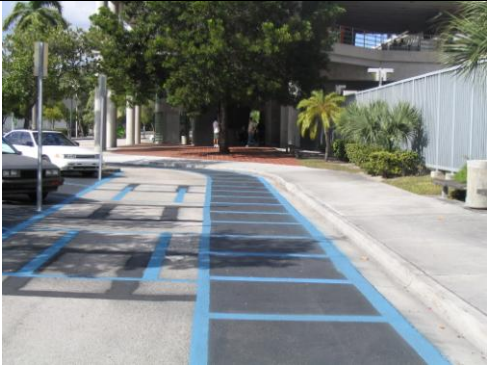
6/15/04
ENTRANCE	13. Entrances: Previous findings: The station is identified by a visual sign. There are three entrances: (1) from drop-off, a surface	There are three accessible entrances to the station: (1) From "van accessible" spaces and passenger loading zone,	Exhibit 3-15(a) Station Entrance 1 – Van Accessible Parking Area	6/15/04

OKEECHOBEE DECEMBER 2003 ASSESSMENT	FINDINGS	CORRECTIVE ACTION	EXHIBITS	DATE ITEM CURED
	<p>parking and walk-on, (2) from the bus bays, and (3) from the parking garage Level 3. Entrance number 1 has a tactile station name sign over the elevator hall call buttons which has upper /lower case raised letters.</p> <p>The deficiency has been corrected, as shown in Exhibits 3-15(a) and (b). However, the raised letter and Braille entrance sign is mounted at 48 inches above the walkway surface.</p>	<p>as shown in Exhibits 3-15(a) and 3-15(b),</p> <p>(2) From the bus bays, as shown in Exhibits 3-15(c) and 3-15(d), and</p> <p>(3) From the parking garage Level 3, as shown in Exhibits 3-15(e) and 3-15(f).</p> <p>Braille/raised letters entrance signs were installed at the three entrances. Entrance 1 from the “van accessible” parking spaces area and from the drop-off area; Entrance 2 from the bus bays; and, Entrance 3 from the parking garage, Level 3 areas.</p>

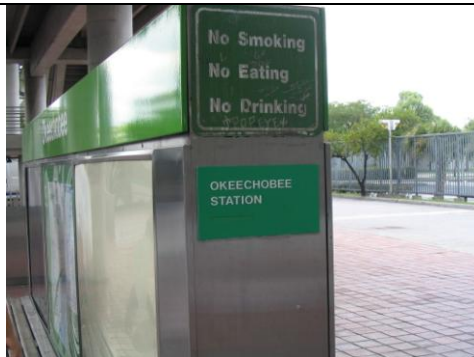
<p>Previous finding: Entrances 2 and 3 do not have tactile station name signs. These deficiencies remain.</p>	<p>Braille/raised letters entrance signs were installed at the three entrances. Entrance 1 from the “van accessible” parking spaces</p>	<p>Exhibit 3-15(c) Station Entrance 2 Bus Bays South Entrance</p>	<p>6/15/04</p>

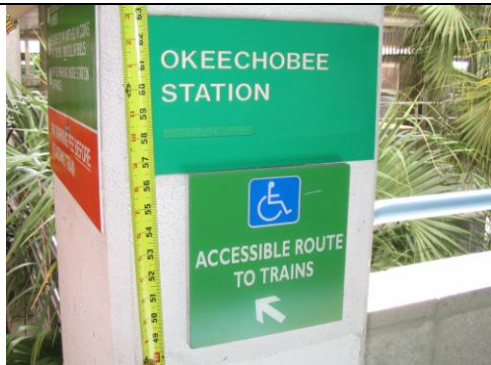
Previous finding: Entrances 2 and 3 do not have tactile station name signs. These deficiencies remain.	Braille/raised letters entrance signs were installed at the three entrances 2 and 3, as shown in Exhibits 3-15(e) and 3-15(f).	Exhibit 3-15(e) Station Entrance 3 – Parking Garage Level 3 Areas	6/15/04

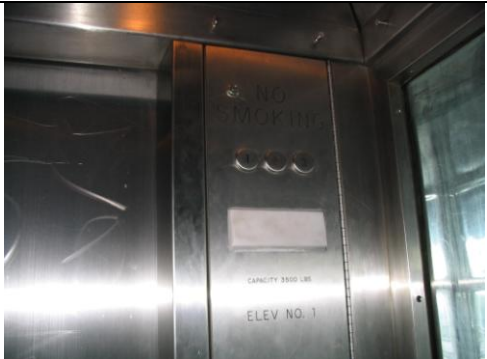
ELEVATOR	Previous findings: • Hall call buttons on Elevators 1 and 2 are 37 inches and 39 inches above the floor.		Exhibit 3-15(1) Elevator 1

OKEECHOBEE DECEMBER 2003 ASSESSMENT	FINDINGS	CORRECTIVE ACTION	EXHIBITS	DATE ITEM CURED
	<ul style="list-style-type: none"> • The hall call buttons do not light on all levels of Elevators 1 and 2. • There is no hoistway signage on one jamb and no Braille on the other jamb at all levels of Elevators 1 and 2. • The control buttons on Elevators 1 and 2 have ¼ inch raised characters. • The car position indicators in Elevators 1 and 2 are ¼ inch high. • The emergency communication device is not identified on elevators 3 and 4 and requires voice communication. . <p>These deficiencies have been corrected, as shown in Exhibits 3-15(1), (2), (3), (4), (6), and (7).</p>

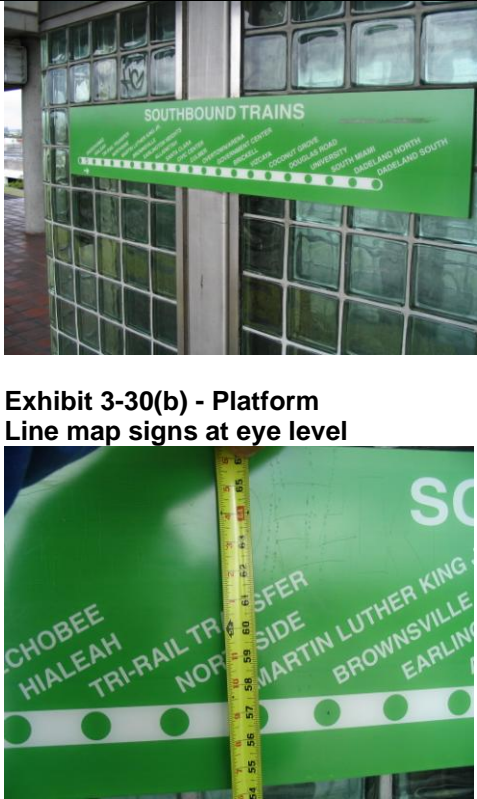
OKEECHOBEE DECEMBER 2003 ASSESSMENT	FINDINGS	CORRECTIVE ACTION	EXHIBITS	DATE ITEM CURED
AUTOMATIC FARE VENDING AND COLLECTION	<p>Previous finding: the parking fare machine coin slots are all in excess of 54 inches above finish floor. They range from 56 to 59 inches.</p> <p>The deficiency has been corrected</p>			
	<p>Previous findings: There are no tactile or audio instructions for the vision impaired on the token/change vendors.</p> <p>The deficiency has been corrected.</p>			
	<p>Previous finding: The gates do not have a smooth continuous surface from 2 to 27 inches.</p> <p>The deficiency has been corrected.</p>			
PLATFORMS	<p>17. Previous finding: Some detectable warning edge tiles are missing from both sides of the platform.</p> <p>The deficiency has been corrected.</p>			
	<p>Previous finding: Overhead signs (mounted higher than 80 inches) have a character height of less than one inch. The condition remains. However, the same information is provided in various areas of the station, including the</p>	<p>Line Map (Destination) signs were installed at the platform at the eye level, as shown in Exhibit 3-20.</p>	<p>Exhibit 3-30(a) - Platform Line map signs at eye level</p>

OKEECHOBEE DECEMBER 2003 ASSESSMENT	FINDINGS	CORRECTIVE ACTION	EXHIBITS	DATE ITEM CURED
	platform, as shown in Exhibit 3-20.
